DESCRIPTION OF WORK

Historic Property Descriptions

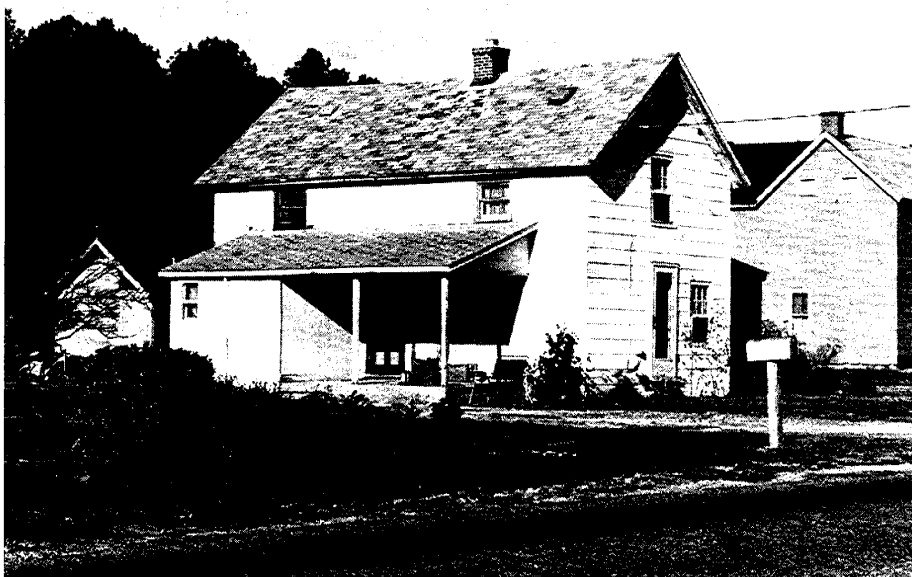
PLATE 38: CRS S-1731
View of south and east facades of tenant house, looking northwest.
Note original windows and fenestration.

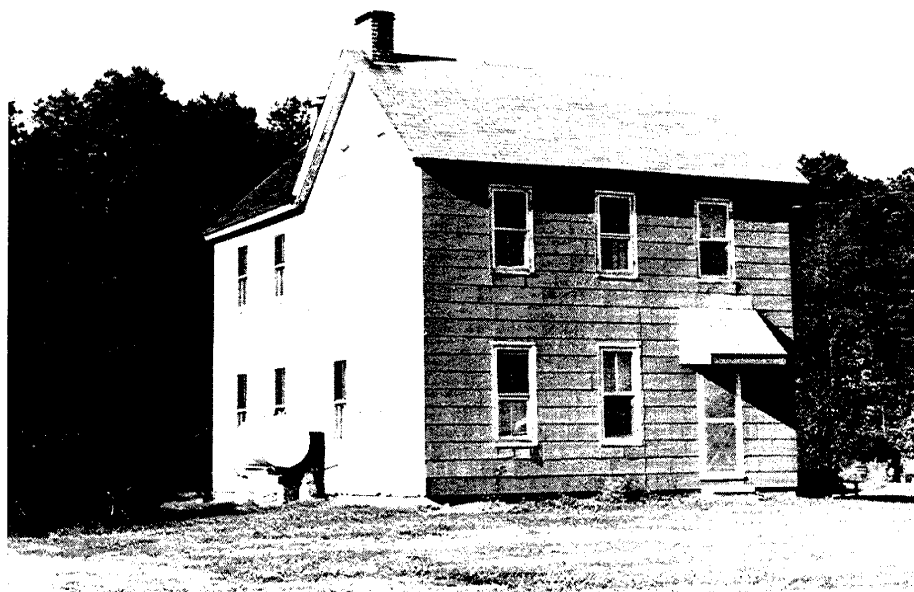
PLATE 39: CRS S-1730
View of south and east facades of house, looking northwest.
Note original fenestration and windows.

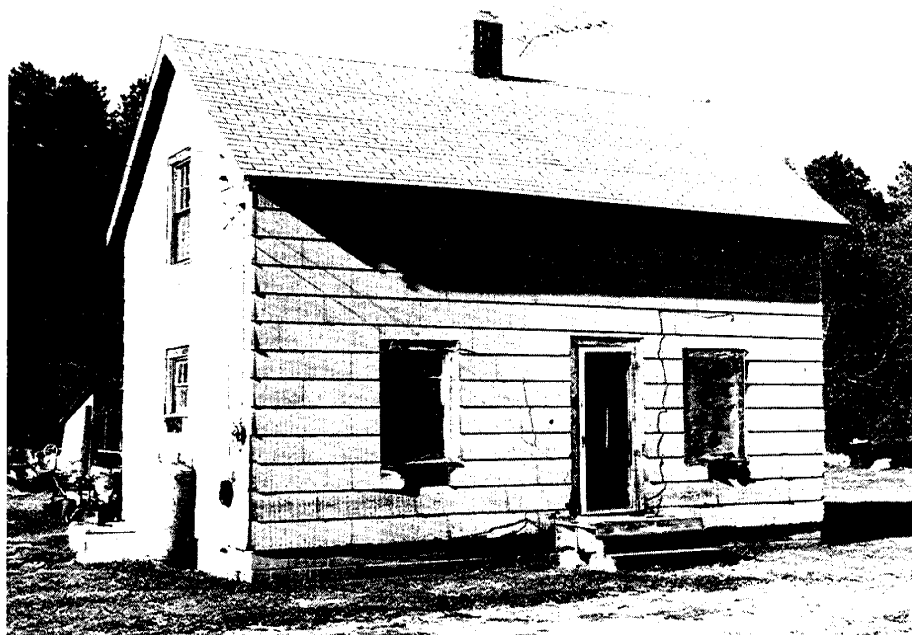
PLATE 40: CRS S-1729
View of south and east facades of tenant house, looking west.
Note original windows and fenestration.

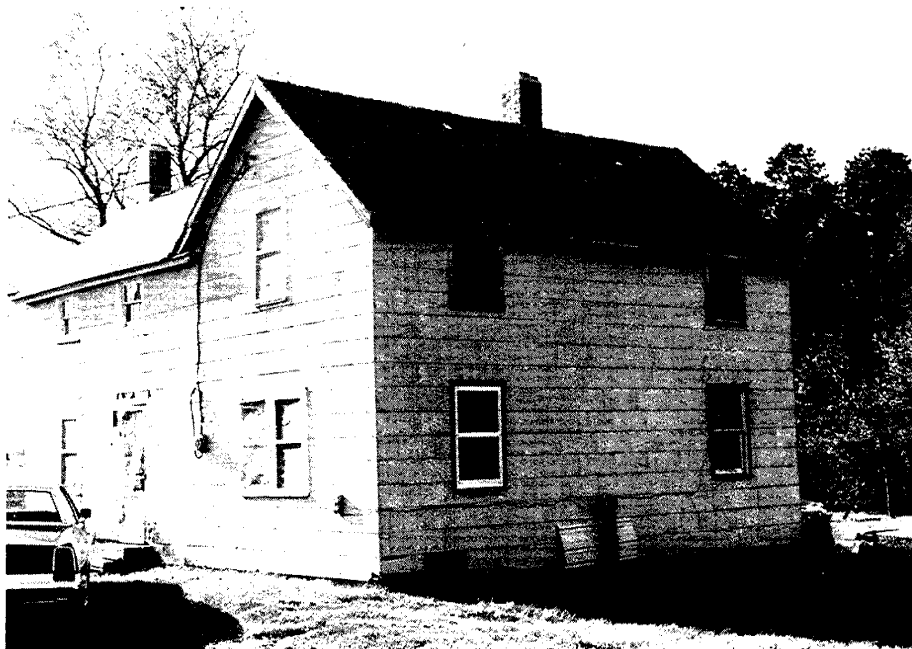
PLATE 41: CRS S-1728
View of east and north facades of tenant house, looking southwest.

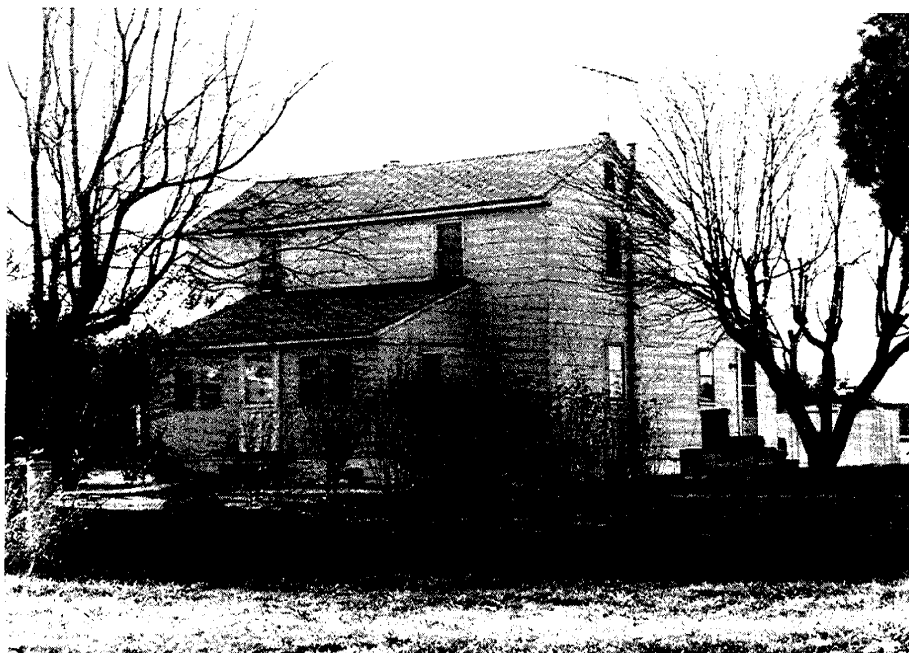
PLATE 42: CRS S-1725
View of east and north facades of house, looking southwest.

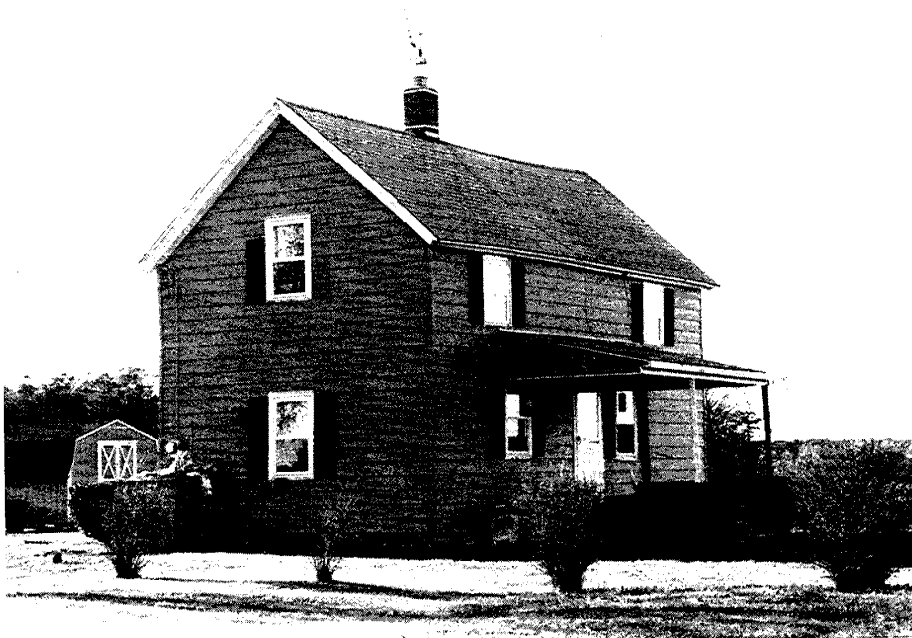
PLATE 43: CRS S-8416
View of north and east facades of house, looking southwest.
Note modern windows and changes to fenestration.

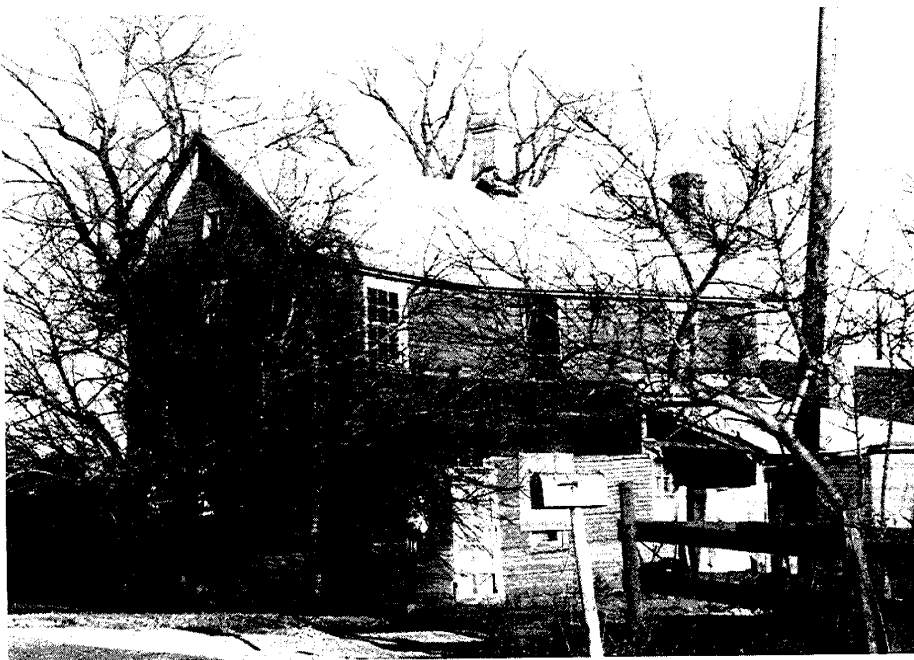
PLATE 44: CRS S-8417
View of heavily altered dwelling, looking southeast.
Trees obscure the building.

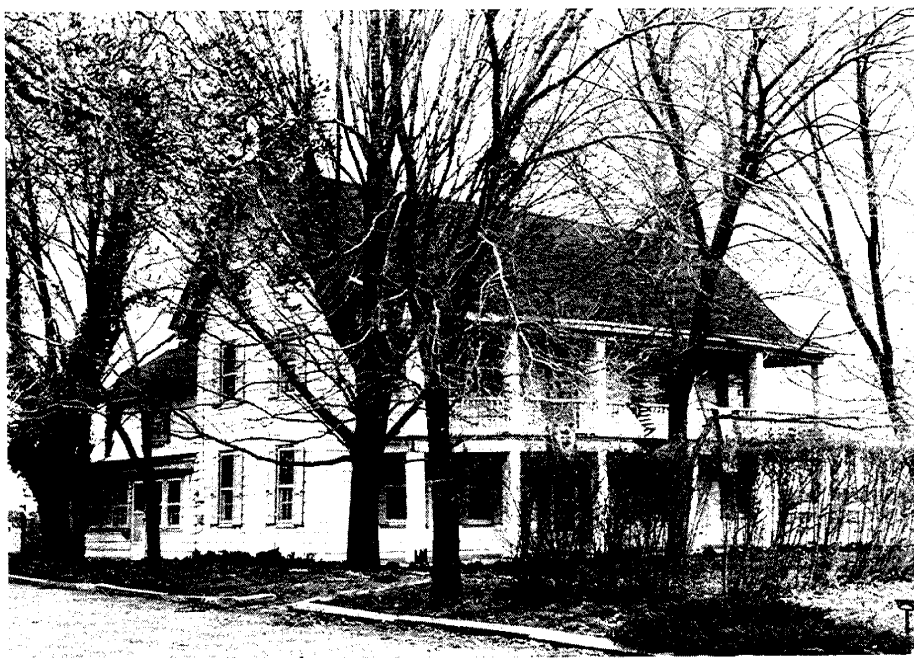
This pre-Civil War mansion is situated on the north side of Road 600, just east of the intersection with Route 13. The house was previously determined eligible, and was listed on the National Register of Historic Places in August 1982. CRS S-1707, S-8418, S-8419, and this house (S-827) comprise the proposed Peach Mansion Historic District. These buildings are significant as an agricultural district that includes the main mansion house and three tenant houses that appear to have been part of the plantation's operation. The district is significant under priority historic context one, Agriculture 1770-1830 and 1830-1880. Although the houses are currently owned by different persons and are on separate parcels, it appears that CRS S-1707, S-8418, and S-8419 may have been tenant houses to the Ricards Plantation, which at one time occupied several hundred acres. This plantation functioned during the nineteenth century as a prosperous peach orchard (Carter 1981).

PLATE 45: CRS S-827
View of south and west facades of house, looking northeast.
House is currently on the National Register of Historic Places.

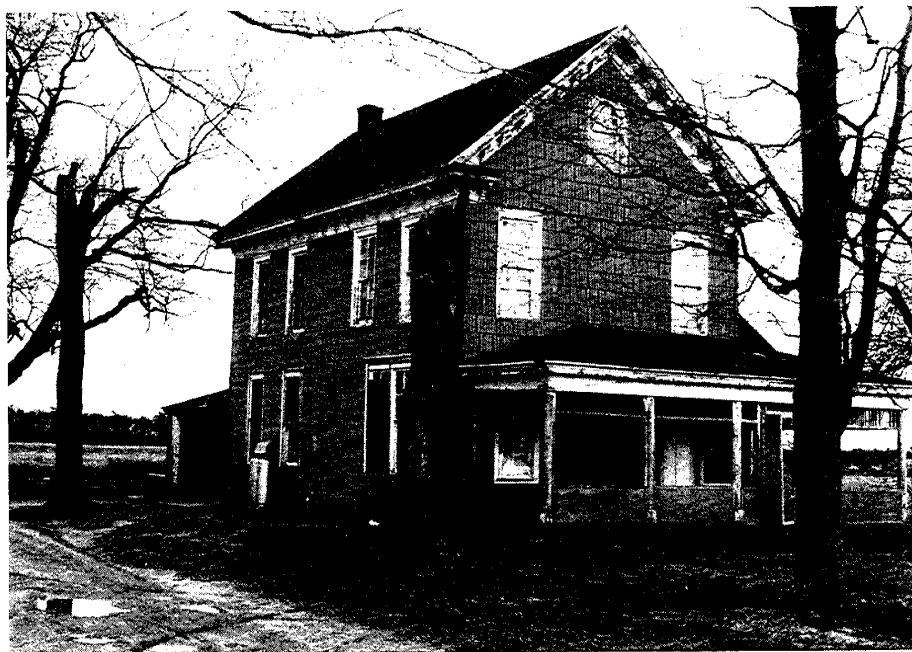
PLATE 46: CRS S-8418
View of north and east facades of house, looking southwest.
Note original fenestration, windows, and cornice details.

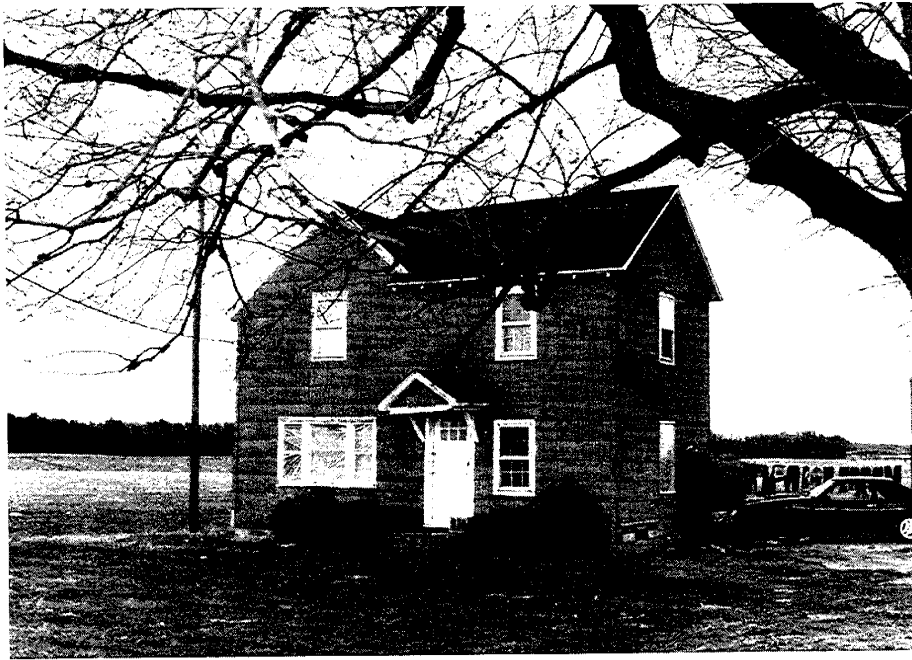
This house is located on the south side of Road 600, just east of CRS S-8418. The T-plan building is two stories with intersecting gable roofs, and a one story, hipped roofed addition on the south facade. The main entrance is placed in the north facade, facing the road. A second entrance is present on the west facade of the one story addition. Most of the windows are six over six and double hung; although, a large, picture window has been inserted in the north facade next to the front door. The house is covered in green, composition shingle siding and sits on a concrete foundation. An exterior, concrete block chimney is situated on the south facade. The building is in poor condition.

This property appears to be eligible as part of the proposed Peach Mansion Historic District. The house, along with CRS S-1707, S-827 and CRS S-8418, is significant as part of an agricultural district. This district includes the main mansion house and three tenant houses that appear to have been part of the plantation's operation. The district is significant under priority historic context one, Agriculture 1770-1830 and 1830-1880. CRS S-827, known as "Linden Hall," or the Ricards House, is located just north of this dwelling on the other side of Road 600. The Ricards House is currently listed on the National Register of Historic Places. Although the houses are presently owned by different persons and are on separate parcels, it

PLATE 47: CRS S-8419
View of north and west facades of house, looking south.

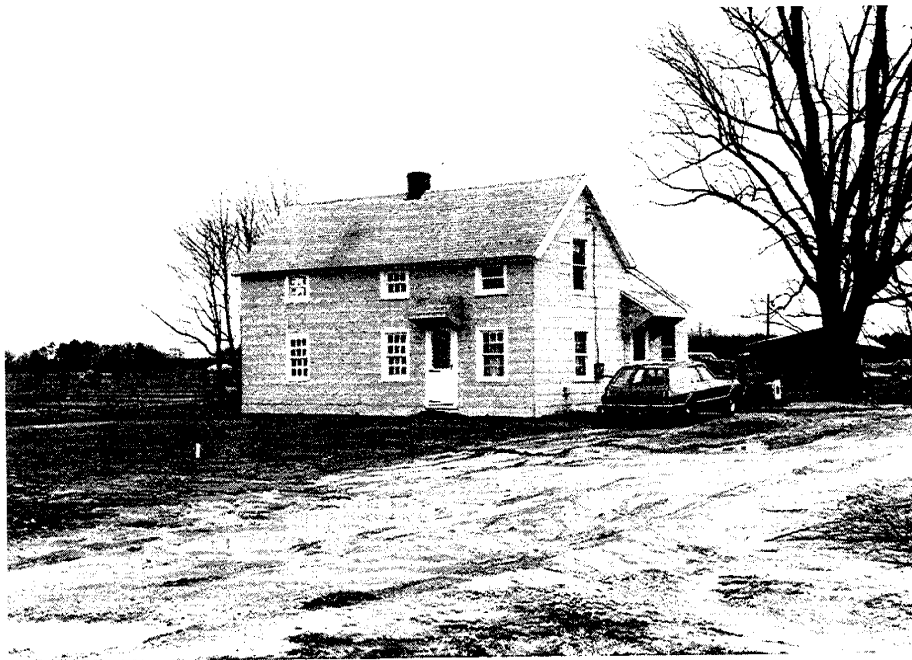
PLATE 48: CRS S-1707
View of west and south facades of house, looking east.
Note original windows and central chimney.

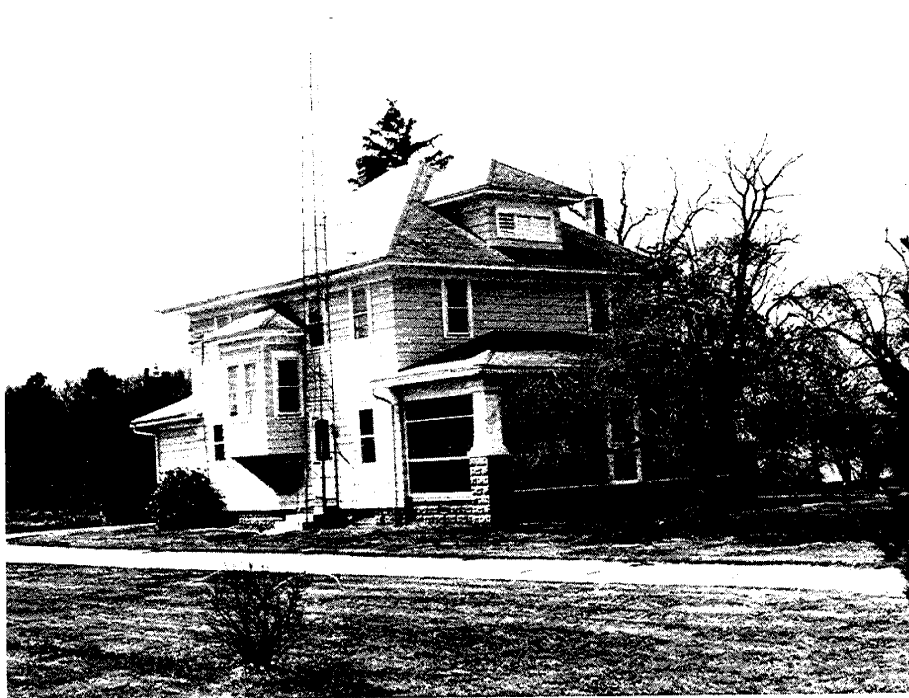
This house appears to date to circa 1910. It appears to be eligible as a contributing member of the proposed, Classical Box, Multiple Property Submission. This thematic district is characterized by two story construction, a square plan with a hipped roof, and a general impression of symmetry. This house retains these qualities and is in excellent condition. As an example of the important trend of suburbanization within the corridor (Herman et. al. 1989:61-2), as well as being architecturally significant, this building is a contributing member of the submission.

PLATE 49: CRS S-1703
View of north and east facades of house, looking southwest.
Note pyramidal roof, massive porch.

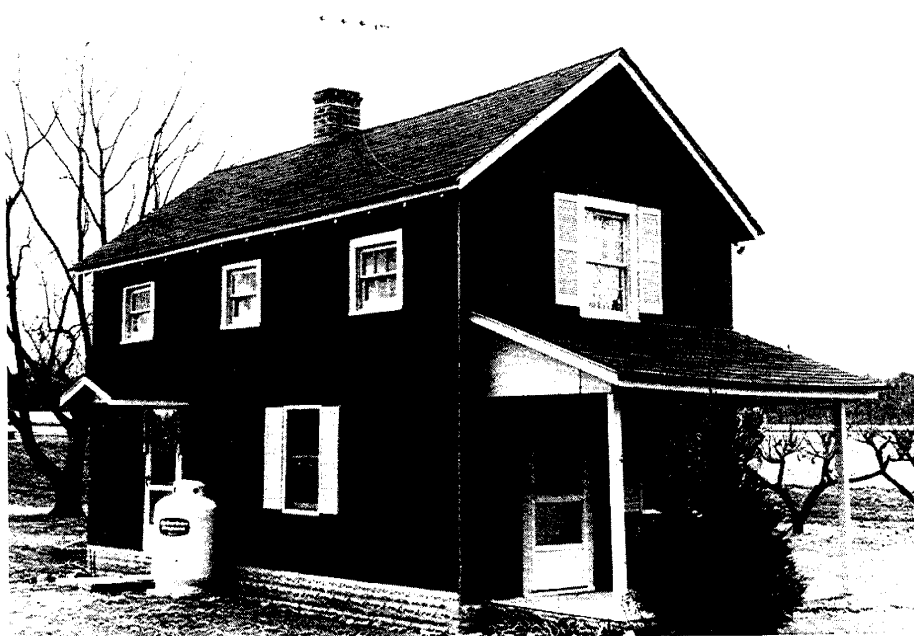
PLATE 50: CRS S-8420
View of north and east facades of house, looking southwest.
Note early windows on second story of east facade.

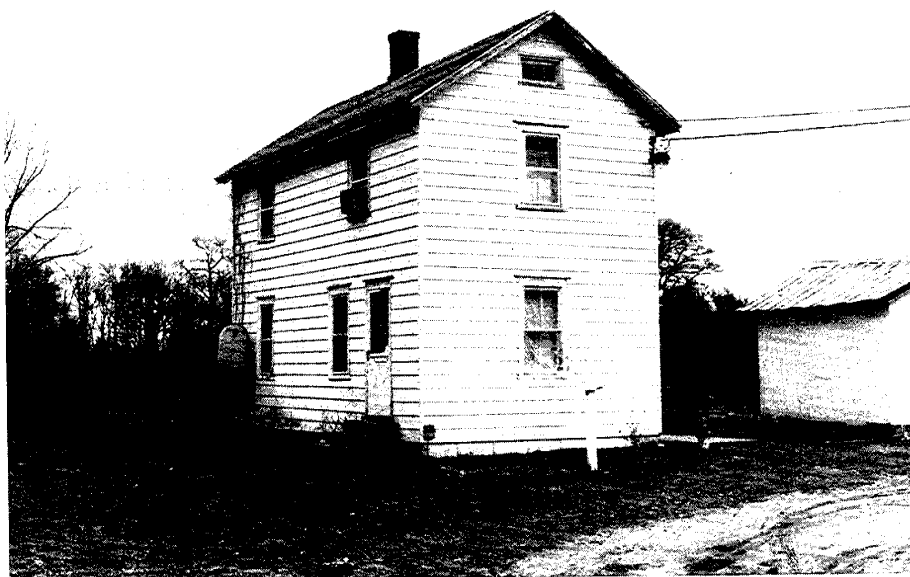
PLATE 51: CRS S-8421
View of north and west facades of house, looking east.
Note original windows at gable and on side facade.

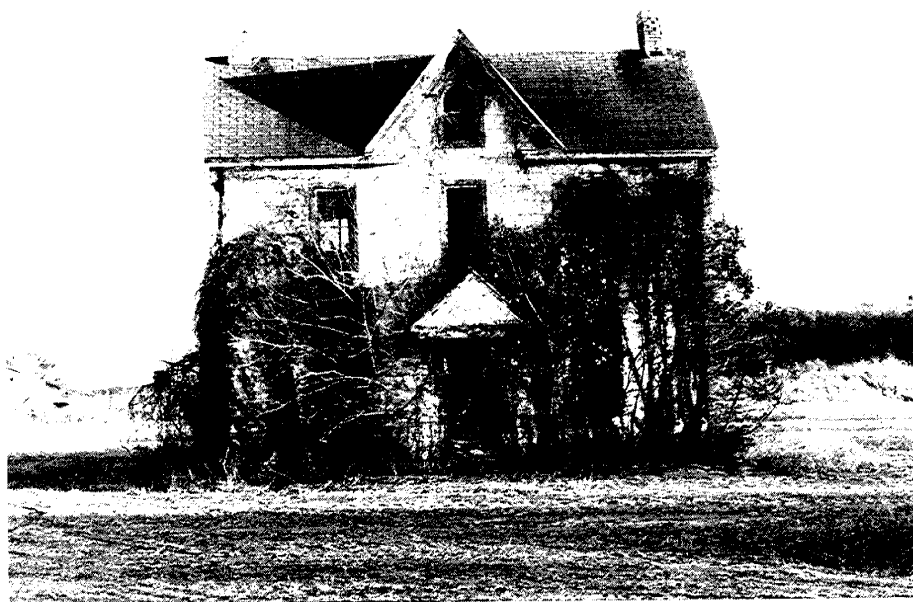
This previously surveyed, abandoned house sits on the south side of Road 40. The two and one-half story, T-plan I-house is three bays wide and two bays deep with a center cross gable in the front facade. The house, although abandoned, still retains its original form and fenestra-

PLATE 52: CRS S-5143
View of north facade of house, looking south.
Note steeply pitched cross gable and pedimented entry porch.
